CRUM CREEK DAM

NDI - PA 00350
PA DER 23-20

PHASE I INSPECTION REPORT NATIONAL DAM INSPECTION PROGRAM

Prepared By
O'BRIEN & GERE
Justin & Courtney Division
PHILADELPHIA, PENNSYLVANIA
19103

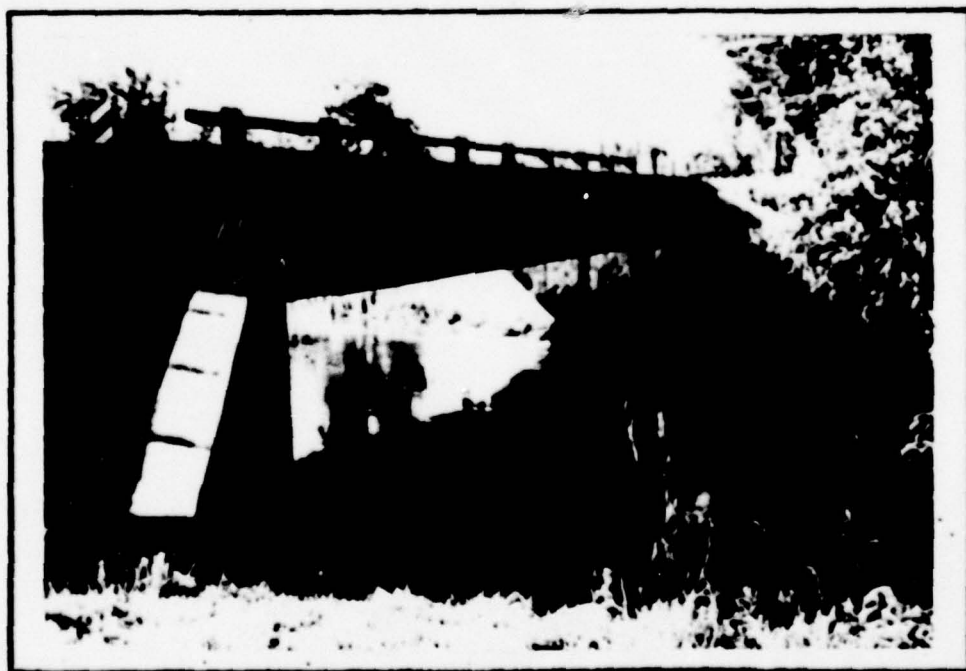
VISUAL EXAMINATION OF	OBSERVATIONS	REMARKS OR RECOMMENDATIONS
CONDITION (OBSTRUCTIONS, DEBRIS, ETC.)	The downstream channel narrows from a 200-foot width below the spillway to about a 40-foot width, 500 feet downstream of the dam. A highway bridge (Beatty Road) is also located about 500-feet below the dam. The bridge opening is 75-feet wide by 15-feet high.	
SLOPES	The overbanks of Crum Creek (downstream of the dam) are relatively flat and well vegetated.	
APPROXIMATE NO. OF HOMES AND POPULATION	The nearest downstream damage center is a small industrial complex. Approximately 100 people are employed within this facility.

*HIGHWAY BRIDGE ABOUT 500 FEET
DOWNSTREAM OF THE DAM*
